# Fire Endurance Tests of Double Module Walls of Gypsum Board and Steel Studs

B. C. Son, H. Shoub

April 1973

Final Report

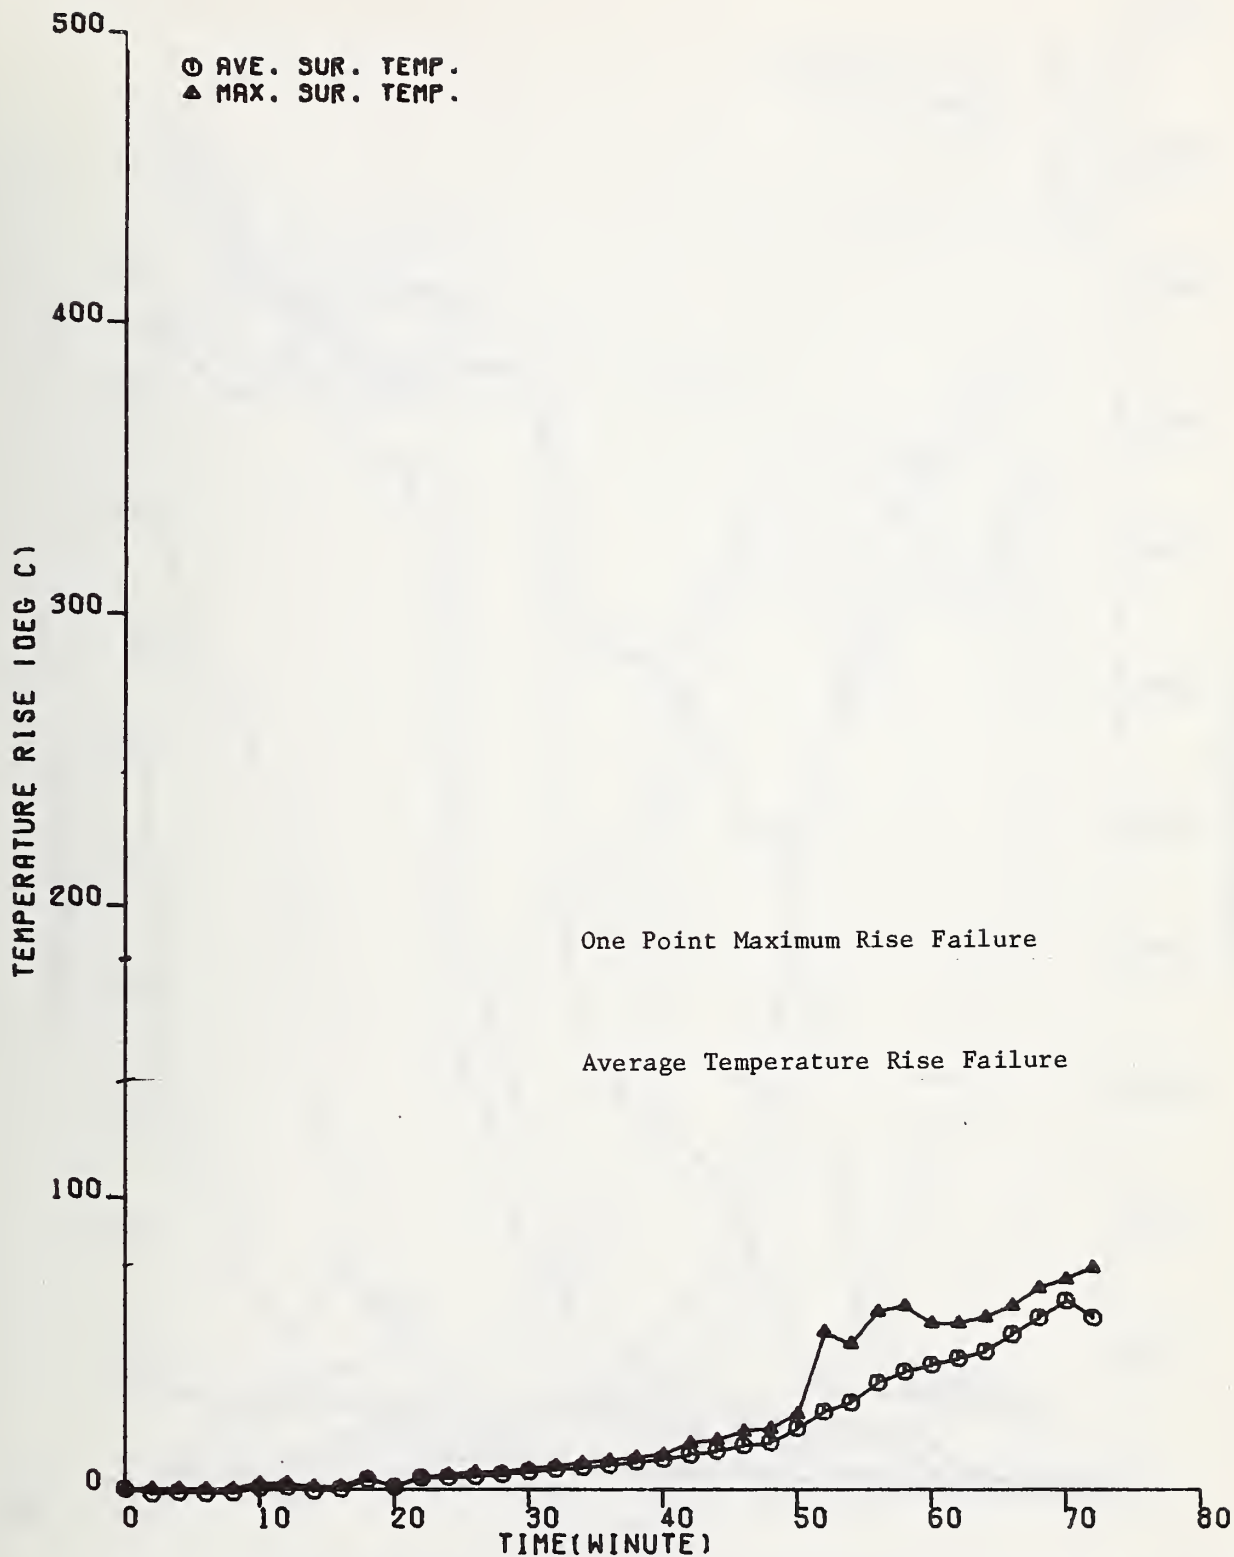
As can be seen in Figure 5, temperature rise at the thermocouple locations on the unexposed surface did not approach the limiting rises established as criteria of failure in the ASTM E 119 standard. There was little temperature variation over the surface as indicated by the close correspondence of the maximum one point and average temperature curves. The temperature gradient across the wall assembly can be seen in Figure 6 (maxima) and Figure 7 (average).

Figure 5 - Maximum and Average Temperature Rise on the Unexposed Surface Wall No. 1

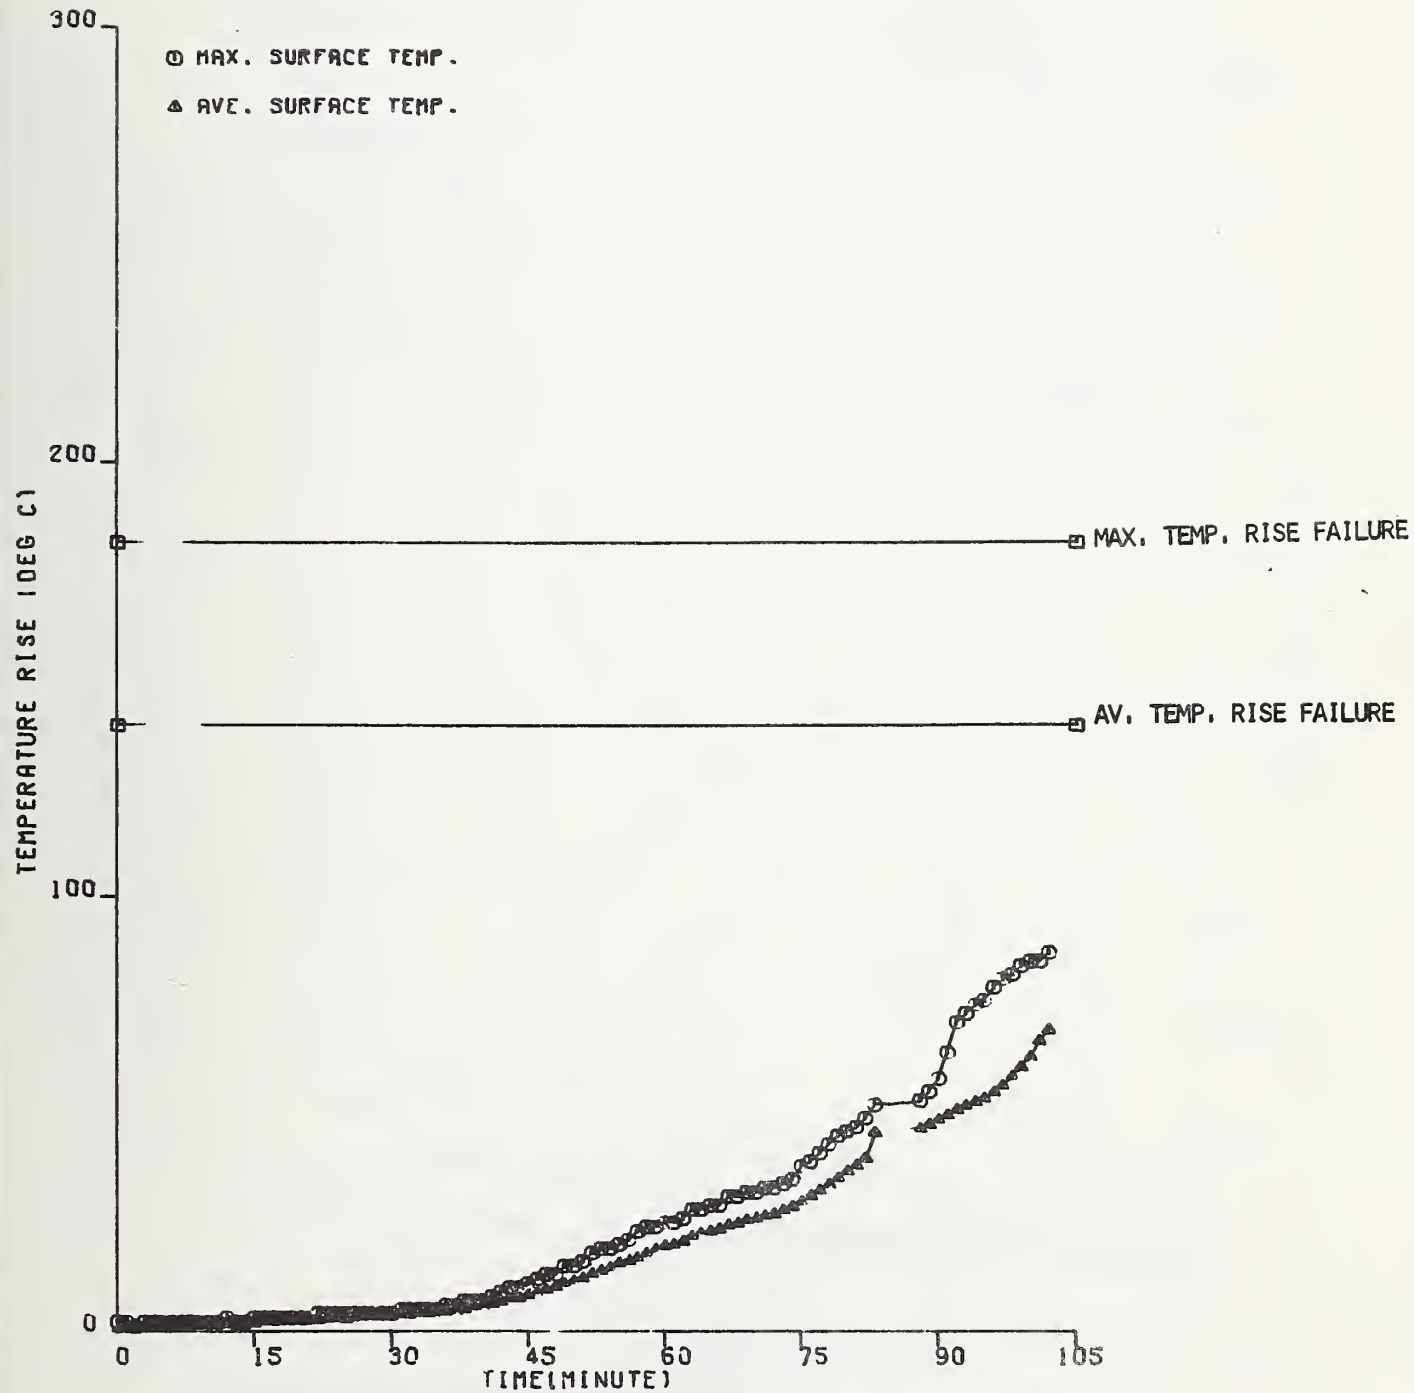
As could be expected from the results of the tests on the first wall, temperature rises on the unexposed surface remained considerably below the limits established as failure points in the fire test standard (Figure 9). Here again there was little variation in temperatures over the surface, with maximum temperatures only slightly greater than averages. Temperature gradients across the wall assembly were also

Figure 9 - Maximum and Average Temperature Rise on the Unexposed Surface 2nd Wall

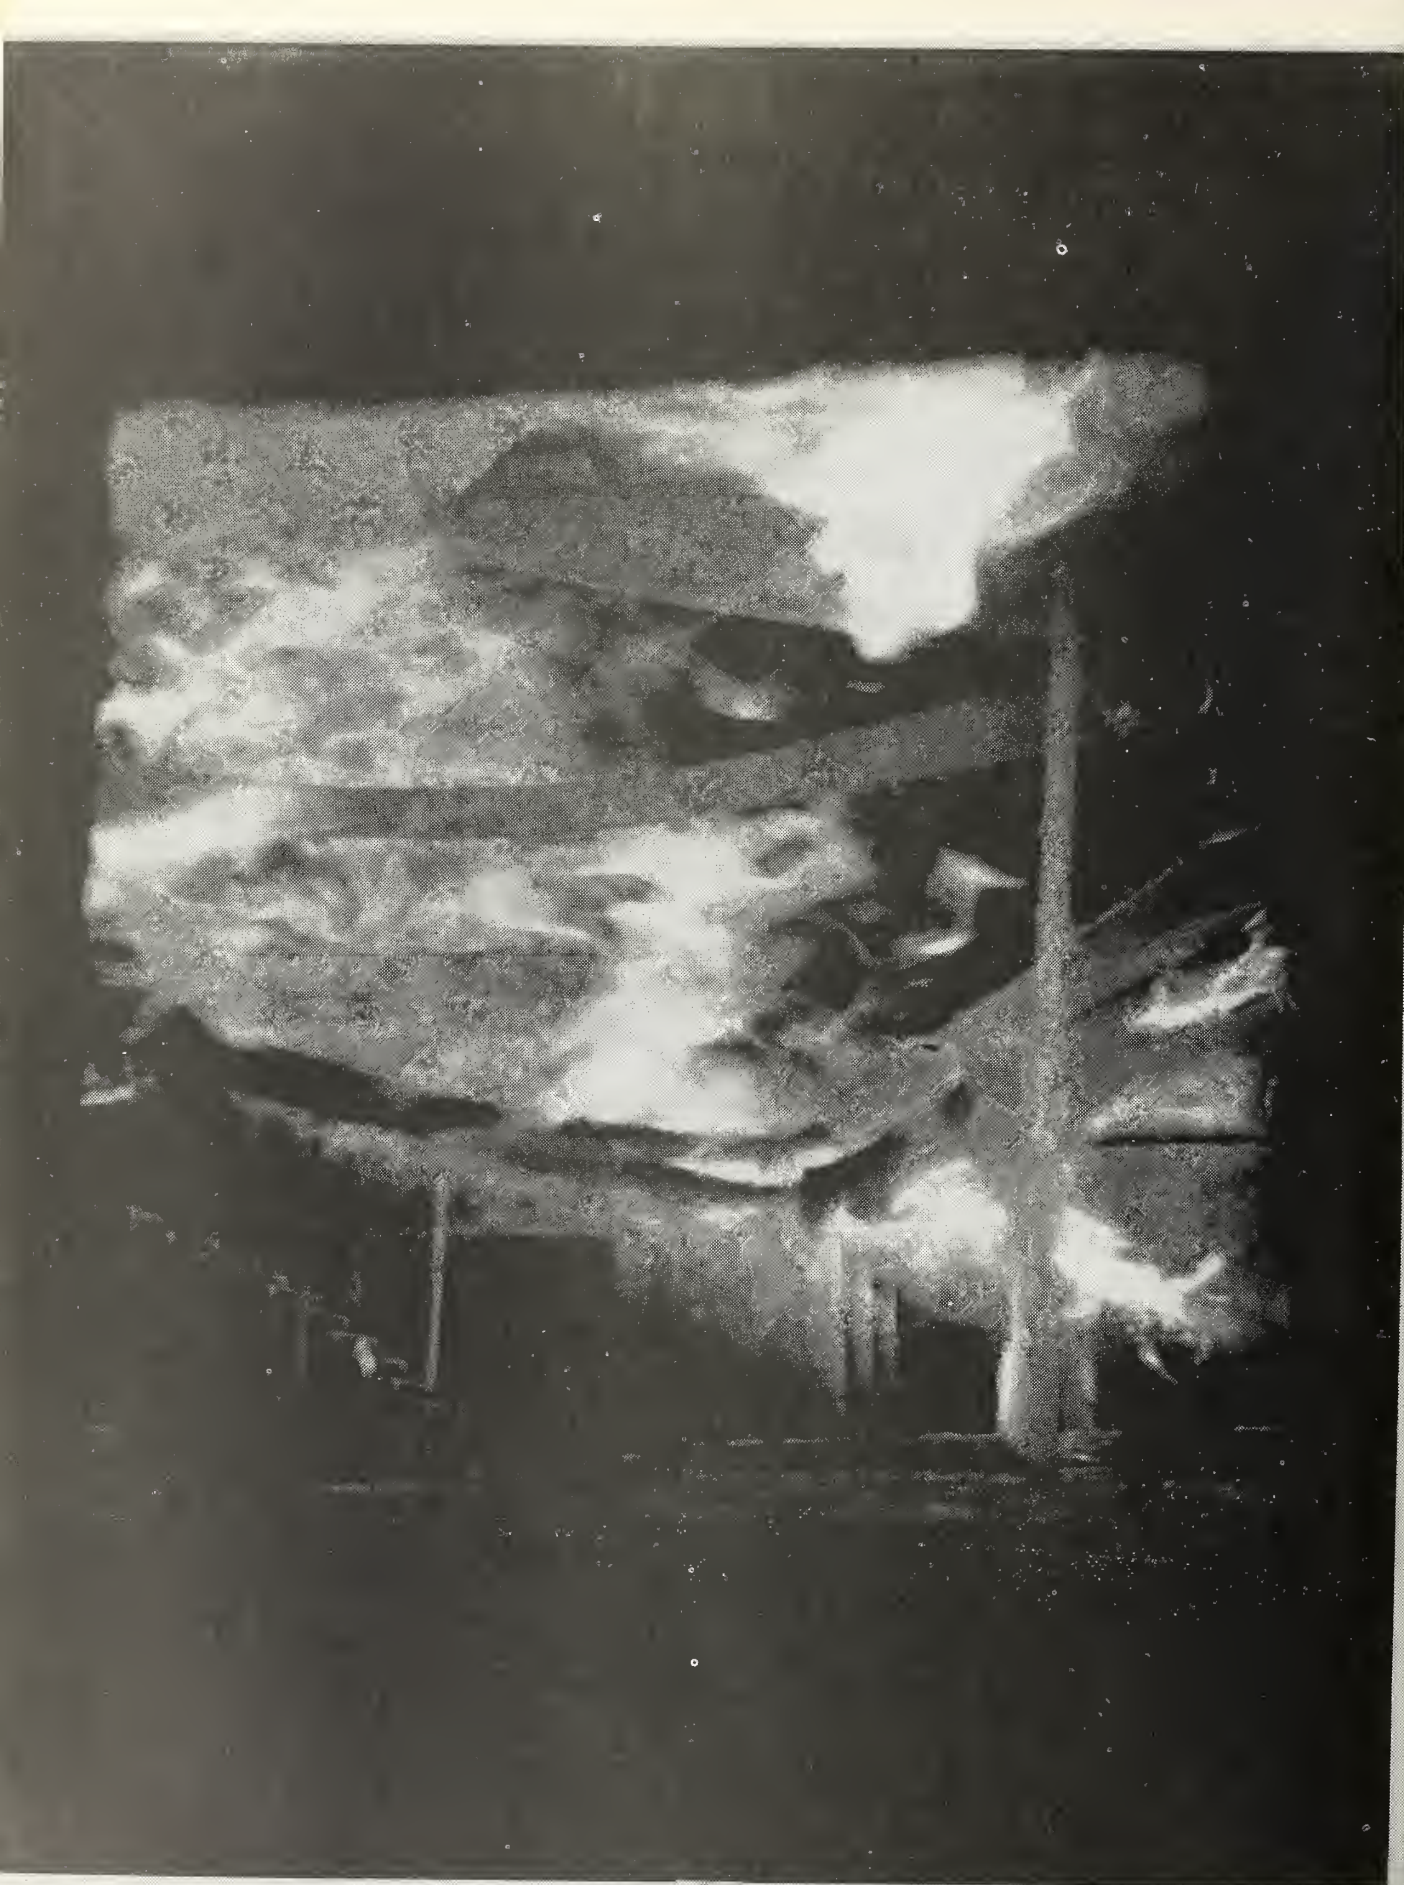
appeared in a fire exposed board at 21 minutes, and in all boards on the fire side by 34 minutes, with visible buckling. By 41 minutes, just prior to failure, there was considerable falling away of the fire exposed board, exposing the studs in the inner wall (fire-exposed). At 58 minutes the boards of the inner wall had fallen away sufficiently to allow full exposure of the inner face of the outer wall. Just prior to failure of the outer wall, there was considerable opening of board joints with consequent rapid buckling of the studs.

An examination of the walls after the tests indicated that the "C" type studs of the first test specimen twisted in failure, probably because of their asymmetry, while the tubular studs of the second test specimen exhibited simple buckling, which left the welds intact (Figures 12 and 13, respectively). The studs were changed to the tubular shape for the second test specimen to provide higher strength without increase in wall thickness. An alternate method of obtaining a higher fire endurance level with the "C" type studs would be by the use of additional layers of gypsum board.

Figure 12 - First Test Specimen, Exposed Side Near End of Test, Studs Twisted

From the results of these tests, it can be seen that a single layer of 5/8-inch Type "X" gypsum board will not provide protection to "C" type steel studs from failure under load for a one hour fire endurance period. Besides the applied load, critical factors include the size and shape of the studs and the quality of the gypsum board joints. In these tests a particular source of weakness appeared to be the joints between the gypsum boards where the filling compound was either quickly destroyed or loosened, allowing rapid heat transmission to the studs. This suggests that a better practice would be the use of a two layer construction, with application of the boards staggered to eliminate direct heat access to the steel through joints.

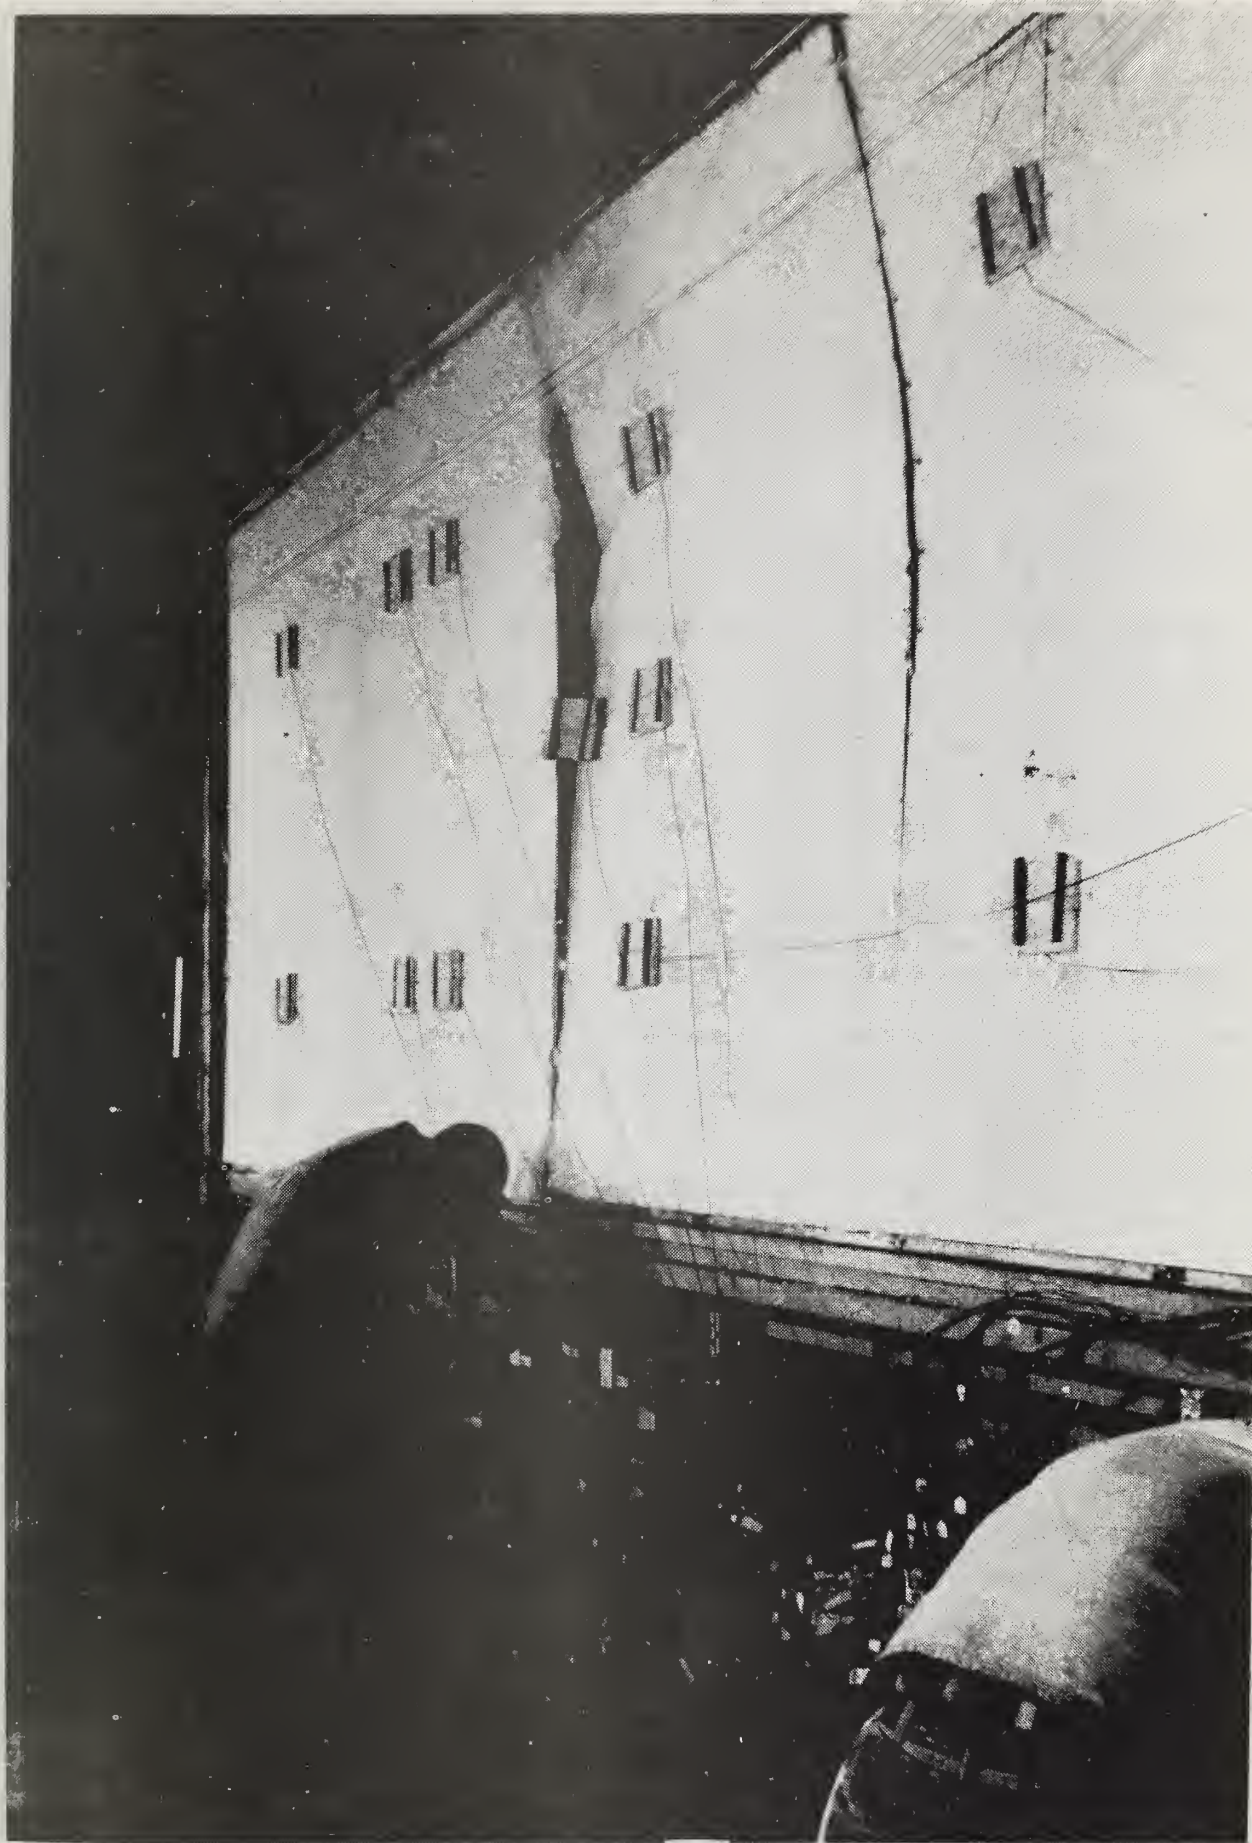
Visual observations indicated flaming occurred at the joints on the fire-exposed surface at 3 minutes. Cracks in the boards appeared at 23 minutes and by 34 minutes had opened to about 3/8 inch. At 48 minutes an end panel began to disintegrate, exposing the fiber glass insulation. By 1 hour the studs of the exposed wall were bowing toward the fire leading to load failure at 1 hour 7 minutes. By 1 hour 20 minutes enough of the wall next to the fire had fallen away to expose a considerable portion of the second wall. After this there was progressive opening of the joints of the second wall, on the side toward the fire

and then on the unexposed side, causing the 1 hour 37 minute failure by passage of hot gas.

Figure 13 - Second Test Specimen, After Test, Showing Buckling of Unexposed Wall
